PRE-REMEDIATION GRAB GROUNDWATER ISOCONTOUR MAP 8 Rimbach Street Hammond, Indiana		Figure 5 Project 6567

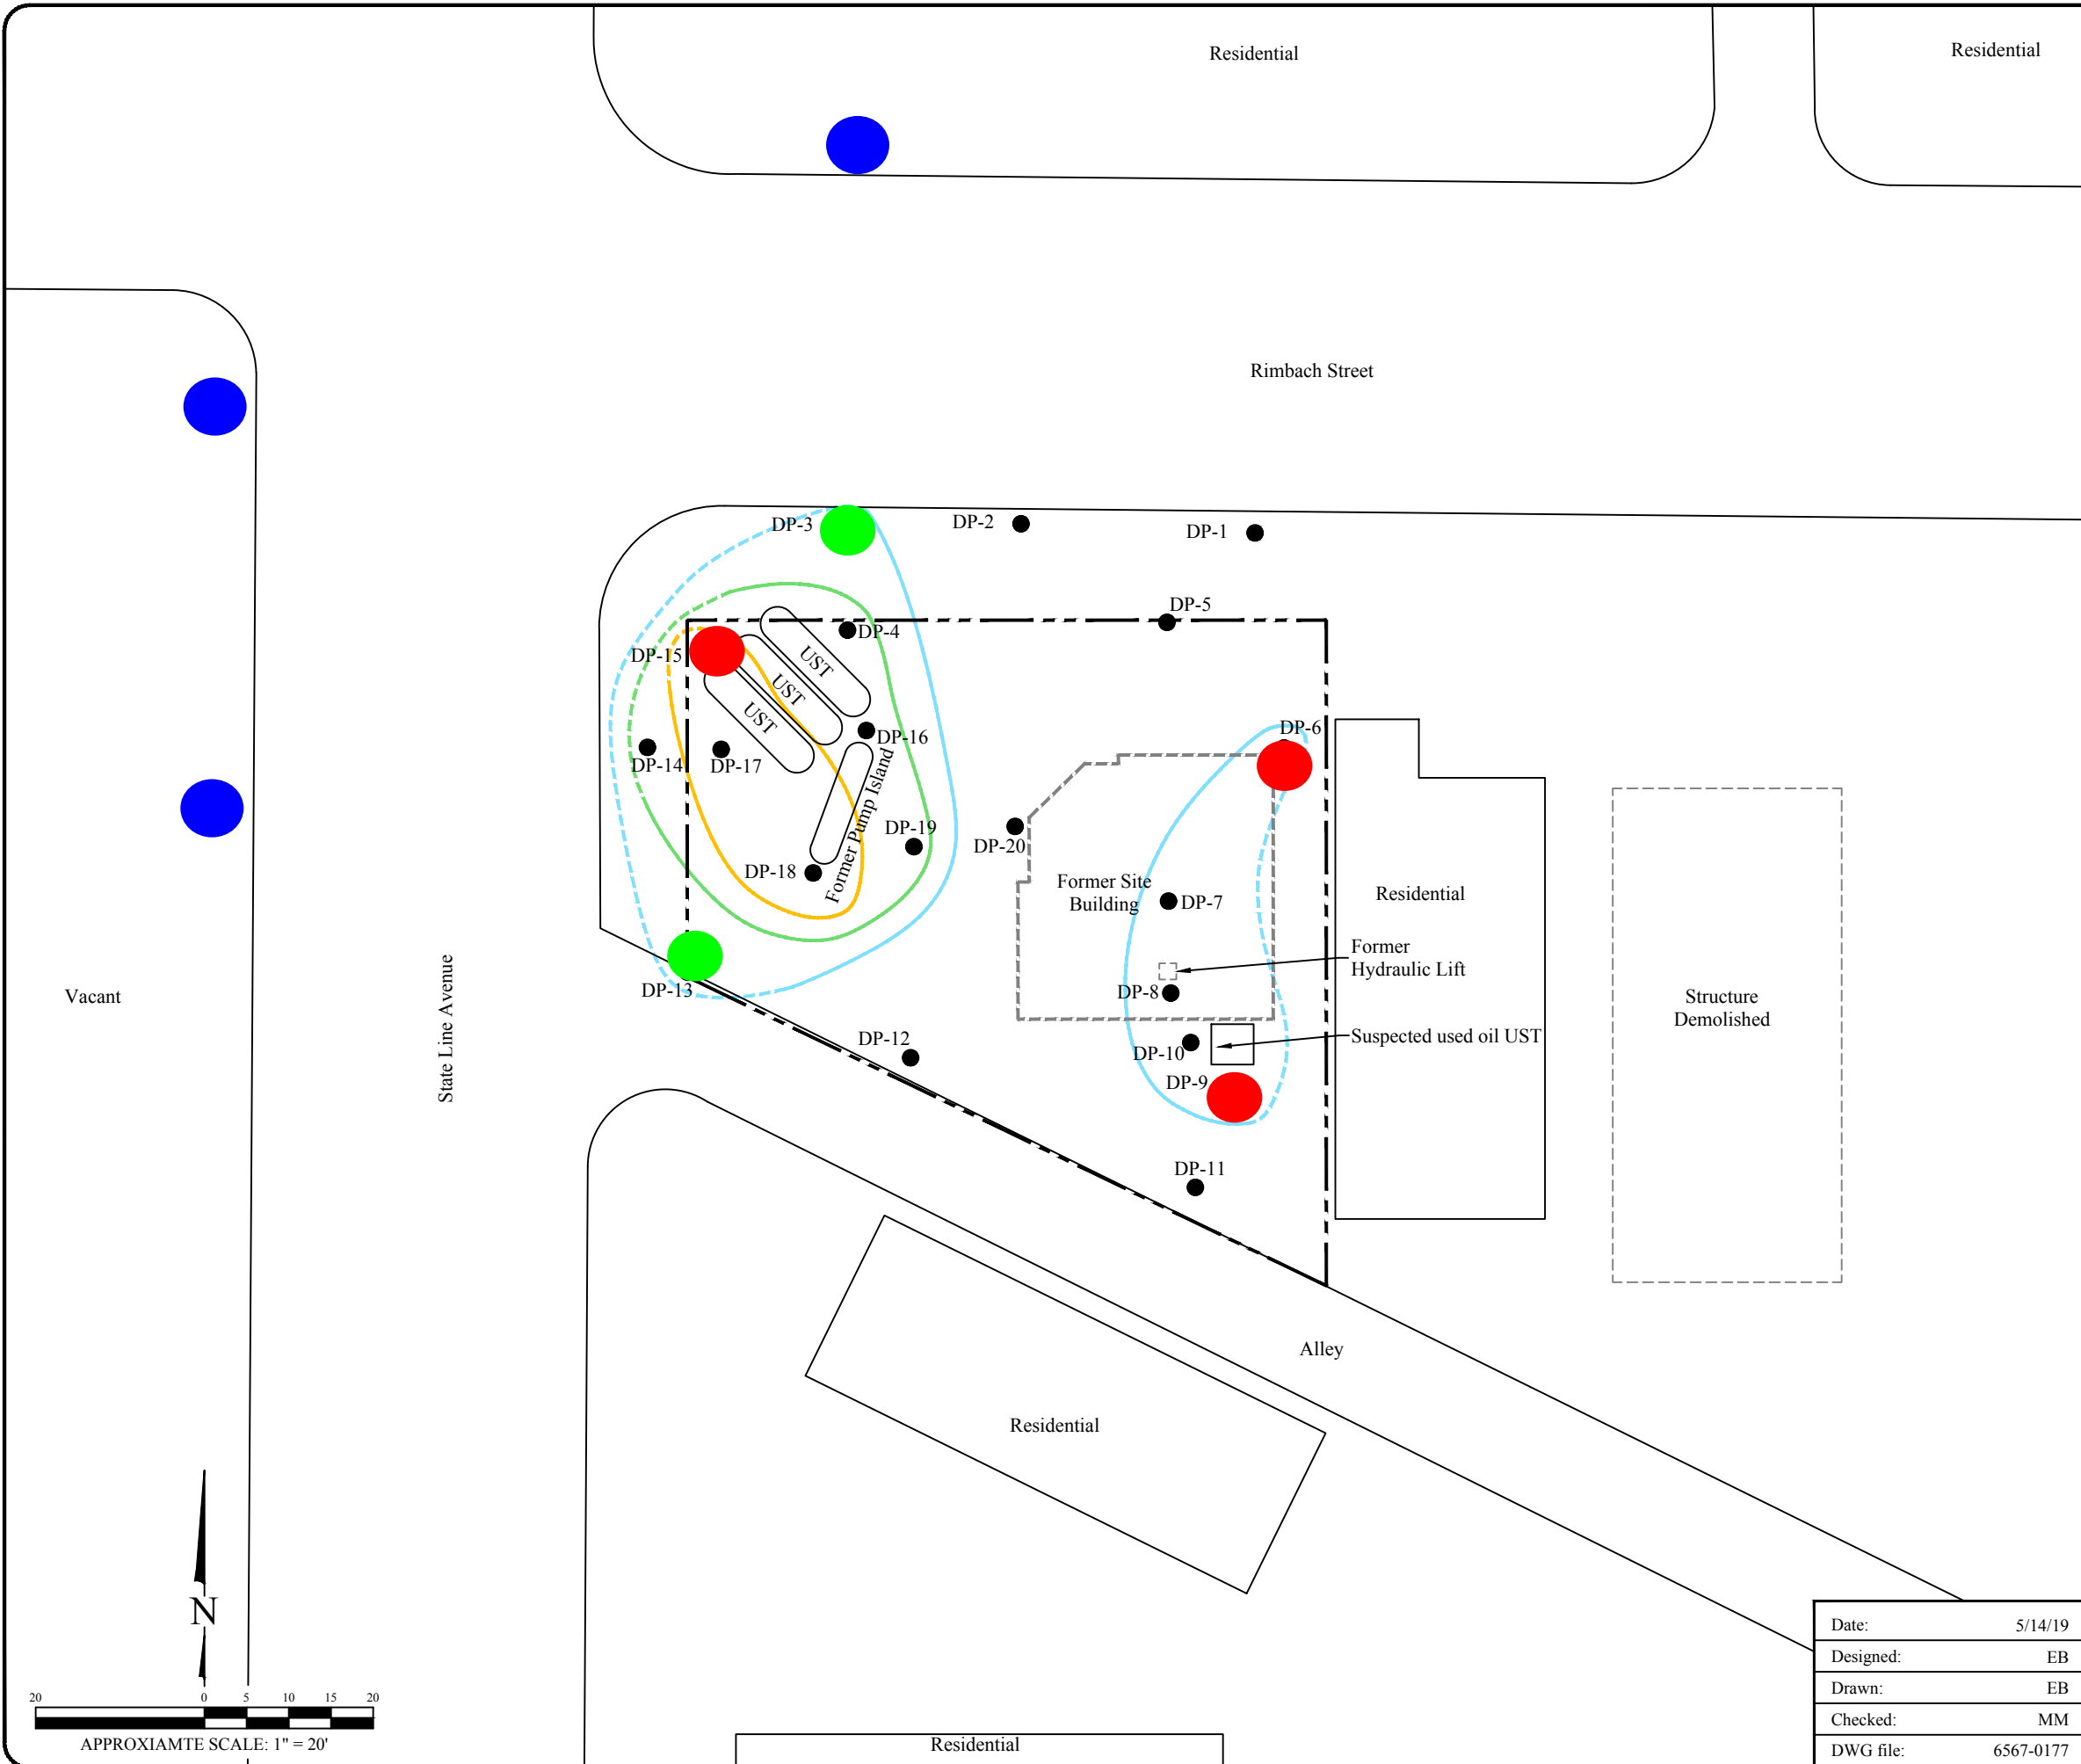
- wells to go in
- borings
- potential well placement
